**Eco Australia**  
100 Furniss Road  
6065 Landsdale  
Australia

**JOB #27207**

**JOB REPORT**

**BLOCKING MACHINE**  
**Doc No 9.2.1.0**

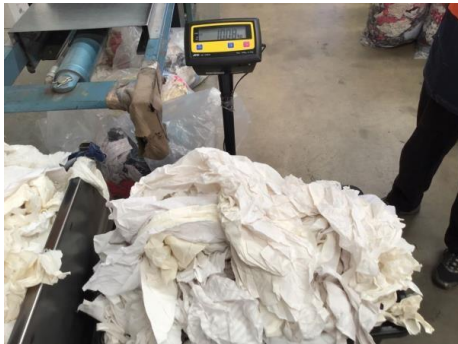
Take a picture of a random 10kg block of Rag or with the weight visible.

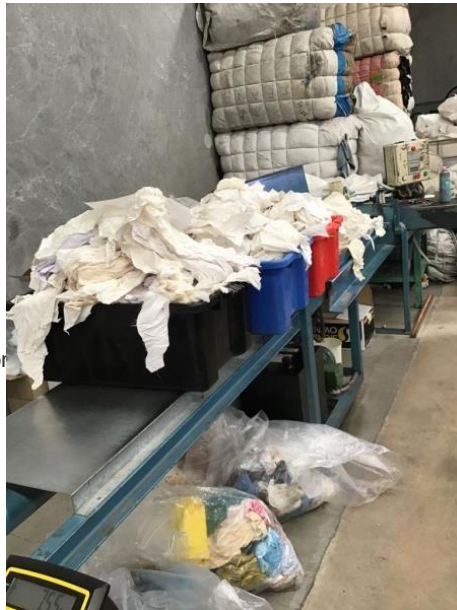
Take a Picture of the entire machine
